**Flood Control Project Maintenance  
Levee Inspections**

## Maintenance Issue Types Only, Levee Inspection Report By Mile - Fall 2018

### Reclamation District No. 0827 Elkhorn

Waterway	Bank	Unit Miles	Inspection Start/End	Inspector
Unit No. 01 Sacramento River	Right	1.34	10/24/2018 10/24/2018	Zach Jojola

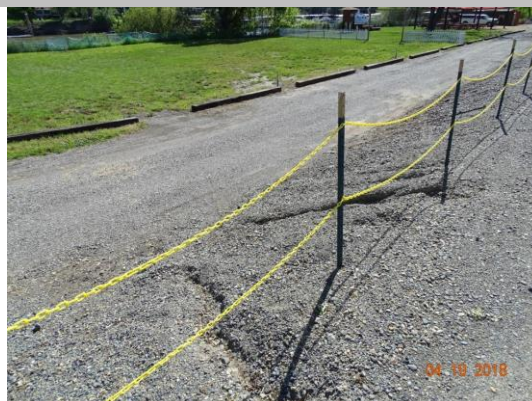
Photo 1 of 1 : FA\_2018\_RD0827\_187\_6\_20180904\_00004.jpg

LM Start	0.04	Rating **	A/W	Issue No.	6
LM End	0.04	Issue Type +	Ma	Location *	WS
Category	Earthen Levee			GPS Latitude/Longitude	
				Start	End
Item	Erosion / Bank Caving			38.674833 °	38.674833 °
				-121.630039 °	-121.630039 °
DWR ID	DWR_RD0827_01_s_2018_6				
Comment Code					
E1 : Note and monitor erosion site.					
Inspector Comment					
Small rills beginning to form on waterside slope. Recommend monitoring.

View of rills on the waterside slope. Spring 2018.

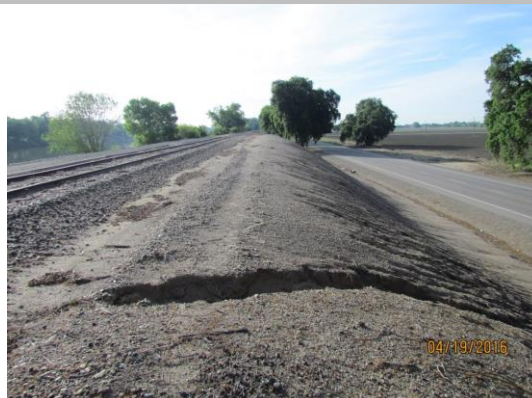
Photo 1 of 2 : FA\_2018\_RD0827\_187\_13\_20180904\_00008.jpg

LM Start	0.51	Rating **	M	Issue No.	13
LM End	0.51	Issue Type +	Ma	Location *	LS
Category	Earthen Levee			GPS Latitude/Longitude	
				Start	End
Item	Erosion / Bank Caving			38.669929 °	38.669929 °
				-121.623776 °	-121.623776 °
DWR ID	DWR_RD0827_01_s_2016_13				
Comment Code					
E2 : Schedule repair of erosion site prior to the next inspection.					
Inspector Comment					
Rills caused by rain.

View of the erosion on the landward side of the levee looking downstream. Spring 2016.

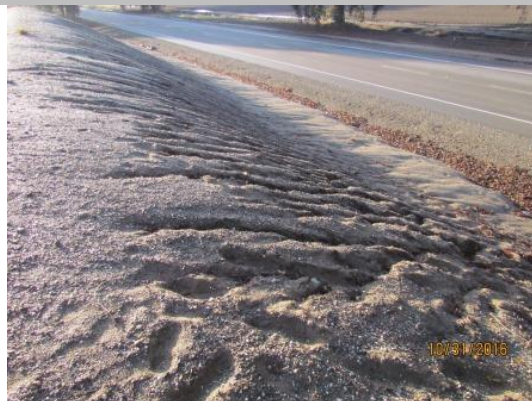
Photo 2 of 2 : FA\_2018\_RD0827\_187\_13\_20180904\_00009.jpg

Updated view of runoff erosion site. LS slope. Fall 2016.

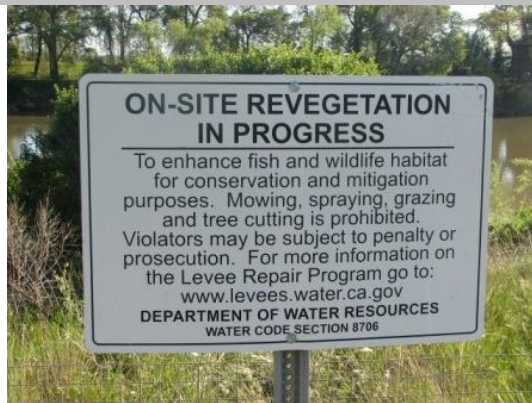
Photo 1 of 2 : FA\_2018\_RD0827\_187\_22\_20180904\_00012.jpg

LM Start	0.61	Rating **	A/W	Issue No.	22
LM End	0.92	Issue Type +	Ma	Location *	WS
Category	Earthen Levee			GPS Latitude/Longitude	
				Start	End
Item	Vegetation			38.668873 °	38.665750 °
				-121.622513 °	-121.618523 °
DWR ID	DWR_RD0827_01_s_2012_22				
Comment Code					
V8 : Environmental Requirements.					
Inspector Comment

Revegetation site spring 2012.

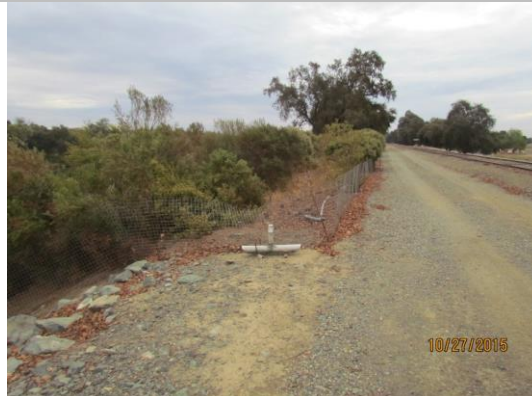
Photo 2 of 2 : FA\_2018\_RD0827\_187\_22\_20180904\_00013.jpg

LM Start	0.61	Rating **	A/W	Issue No.	22 (cont)	
LM End	0.92	Issue Type +	Ma	Location *	WS	
Category	Earthen Levee			GPS Latitude/Longitude		
				Start		End
Item	Vegetation			38.668873 °		38.665750 °
				-121.622513 °		-121.618523 °
DWR ID	DWR_RD0827_01_s_2012_22					
Comment Code						
V8 : Environmental Requirements.						
Inspector Comment

View of the revegetation site on the waterward side of the levee looking downstream. Fall 2015.

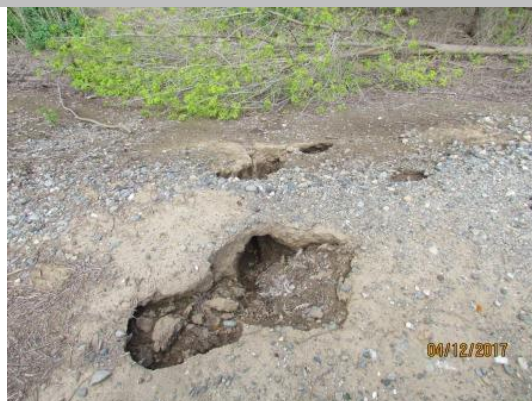
Photo 1 of 3 : FA\_2018\_RD0827\_187\_3\_20180904\_00001.jpg

LM Start	1.12	Rating **	M	Issue No.	3
LM End	1.12	Issue Type +	Ma	Location *	WS
Category	Earthen Levee			GPS Latitude/Longitude	
				Start	End
Item	Erosion / Bank Caving			38.663542°	38.663542°
				-121.616056°	-121.616056°
DWR ID	DWR_RD0827_01_f_2016_3				
Comment Code					
E2 : Schedule repair of erosion site prior to the next inspection.					
Inspector Comment					
Erosion on the crown and waterside slope from runoff.

Updated view of erosion on waterside levee slope. Spring 2017.

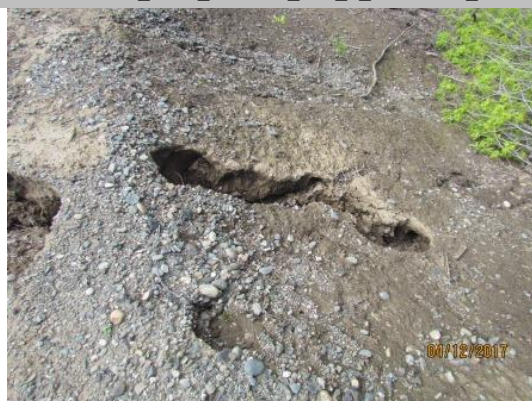
Photo 2 of 3 : FA\_2018\_RD0827\_187\_3\_20180904\_00002.jpg

Another view of erosion on levee slope. A hole on the waterside slope has widened due to runoff. Spring 2017.

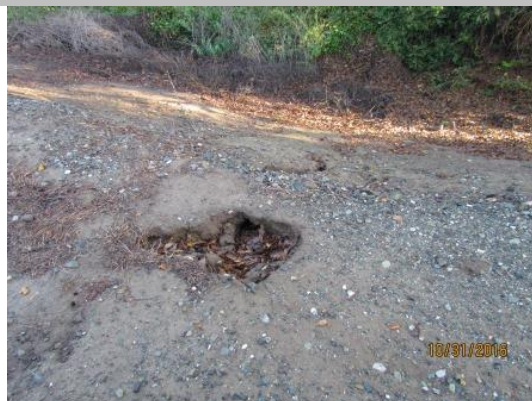
Photo 3 of 3 : FA\_2018\_RD0827\_187\_3\_20180904\_00003.jpg

View of erosion on crown continuing to WS slope. Fall 2016.

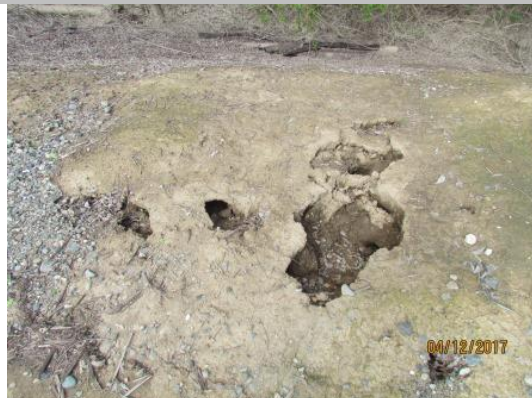
Photo 1 of 1 : FA\_2018\_RD0827\_187\_14\_20180904\_00010.jpg

LM Start	1.14	Rating **	A/W	Issue No.	14
LM End	1.14	Issue Type +	Ma	Location *	WS
Category	Earthen Levee			GPS Latitude/Longitude	
				Start	End
Item	Erosion / Bank Caving			38.663377 °	38.663377 °
				-121.615895 °	-121.615895 °
DWR ID	DWR_RD0827_01_s_2017_14				
Comment Code					
E2 : Schedule repair of erosion site prior to the next inspection.					
Inspector Comment					
Minor erosion on waterside slope. Recommend monitoring

View of erosion on waterside levee slope. Spring 2017.

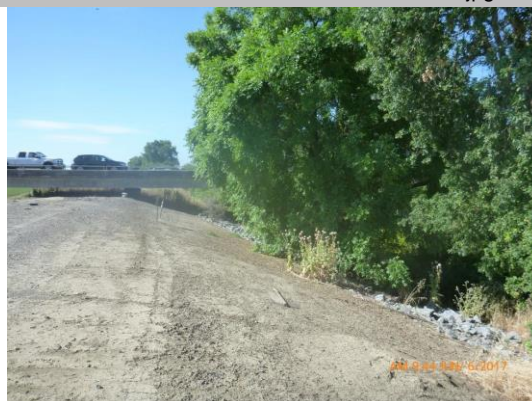
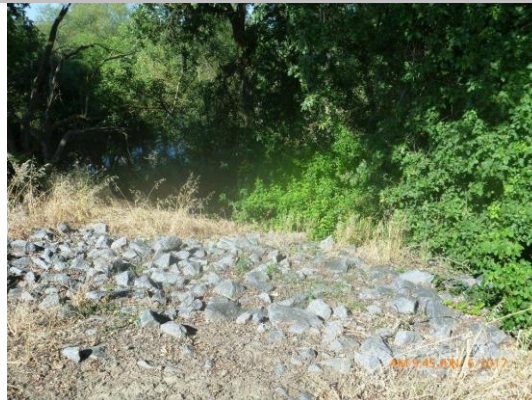
LM Start	0.15	Rating **	A/W	Issue No.	10	
LM End	0.16	Issue Type +	Ma	Location *		
Category	Supplemental			GPS Latitude/Longitude		
				Start		End
Item	2017 Storm Damage			38.674778	°	38.674583
				-121.642806		°
DWR ID	DWR_RD0827_02_f_2017_10					
Comment Code						
Inspector Comment						
Levee Evaluation Comments						
Description:						
Site ID No:200						
Site Designation:RD 827-02						
Repair Type: Erosion						
Rating:Area of Concern						
Field Date:6/6/2017						
Notes: no damage visible, ws armored with riprap

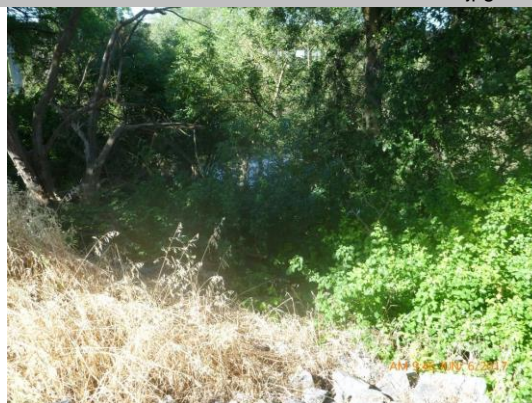
Photo 3 of 3 : LEVAL\_FA\_2018\_200\_1246.jpg

LM Start	0.15	Rating **	A/W	Issue No.	10 (cont)	
LM End	0.16	Issue Type +	Ma	Location *		
Category	Supplemental			GPS Latitude/Longitude		
				Start	End	
Item	2017 Storm Damage			38.674778 °	38.674583 °	
				-121.642806 °	-121.642722 °	
DWR ID	DWR_RD0827_02_f_2017_10					
Comment Code						
Inspector Comment						
Levee Evaluation Comments						
Description:						
Site ID No:200						
Site Designation:RD 827-02						
Repair Type: Erosion						
Rating:Area of Concern						
Field Date:6/6/2017						
Notes: no damage visible, ws armored with riprap

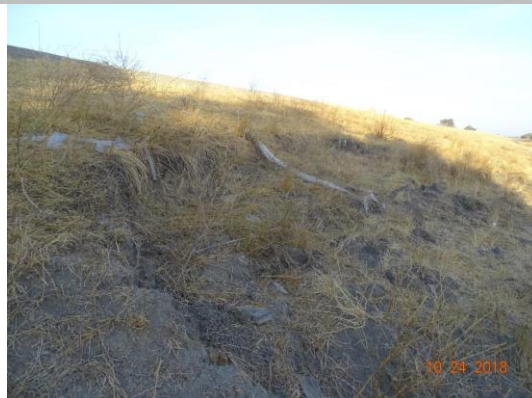
Photo 1 of 6 : FA\_2018\_RD0827\_188\_13\_20181025\_00023.jpg

LM Start	2.72	Rating **	M	Issue No.	13
LM End	2.73	Issue Type +	Ma	Location *	
Category	Supplemental			GPS Latitude/Longitude	
				Start	End
Item	2017 Storm Damage			38.642139°	38.642028°
				-121.620750°	-121.620667°
DWR ID	DWR_RD0827_02_f_2017_13				
Comment Code					
Inspector Comment					
Levee Evaluation Comments					
Description:					
Site ID No:199					
Site Designation:RD 827-01					
Repair Type: Erosion					
Rating:Area of Concern					
Field Date:6/6/2017					
Notes: landside. Visqueen has dried up and is no longer protecting the slope.

Updated view of sloughing on the landside slope. Fall 2018.

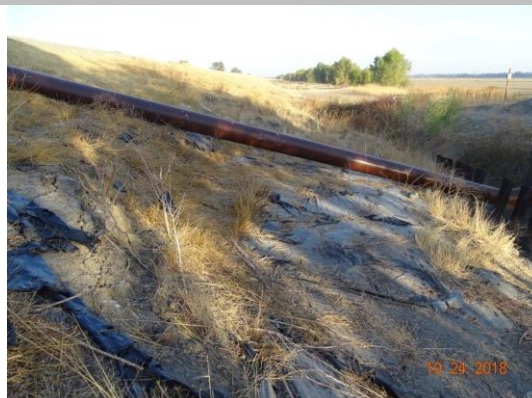
Photo 2 of 6 : FA\_2018\_RD0827\_188\_13\_20181025\_00022.jpg

View of visqueen placed by LMA adjacent to pump. Fall 2018.

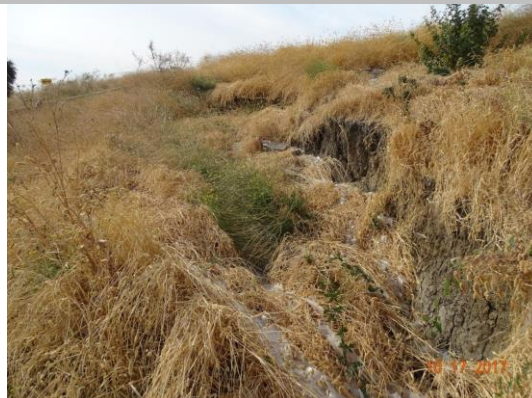
Photo 3 of 6 : FA\_2018\_RD0827\_188\_13\_20180904\_00004.jpg

LM Start	2.72	Rating **	M	Issue No.	13 (cont)
LM End	2.73	Issue Type +	Ma	Location *	
Category	Supplemental			GPS Latitude/Longitude	
				Start	End
Item	2017 Storm Damage			38.642139 °	38.642028 °
				-121.620750 °	-121.620667 °
DWR ID	DWR_RD0827_02_f_2017_13				
Comment Code					
Inspector Comment					
Levee Evaluation Comments					
Description:					
Site ID No:199					
Site Designation:RD 827-01					
Repair Type: Erosion					
Rating:Area of Concern					
Field Date:6/6/2017					
Notes: landslide. Visqueen has dried up and is no longer protecting the slope.

Updated view of sloughing on landside slope. Fall 2017.

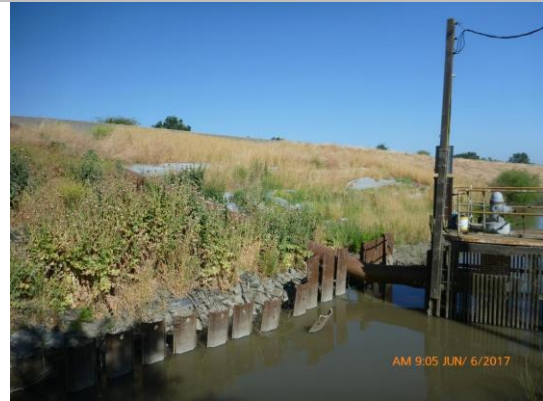
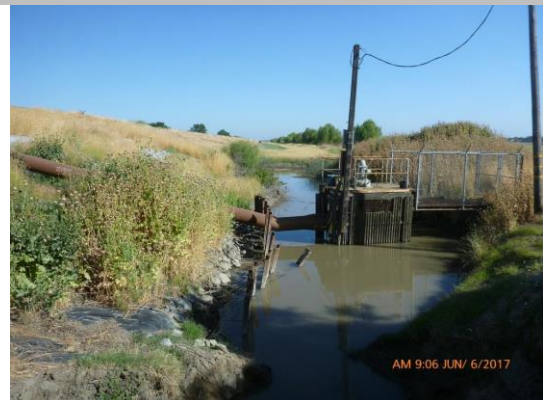
LM Start	2.72	Rating **	M	Issue No.	13 (cont)	
LM End	2.73	Issue Type +	Ma	Location *		
Category	Supplemental			GPS Latitude/Longitude		
				Start	End	
Item	2017 Storm Damage			38.642139 °	38.642028 °	
				-121.620750 °	-121.620667 °	
DWR ID	DWR_RD0827_02_f_2017_13					
Comment Code						
Inspector Comment						
Levee Evaluation Comments						
Description:						
Site ID No:199						
Site Designation:RD 827-01						
Repair Type: Erosion						
Rating:Area of Concern						
Field Date:6/6/2017						
Notes: landslide. Visqueen has dried up and is no longer protecting the slope.
